UCRL-AR-229041

Third Five-Year Review for the Lawrence Livermore National Laboratory Livermore Site

August 2007

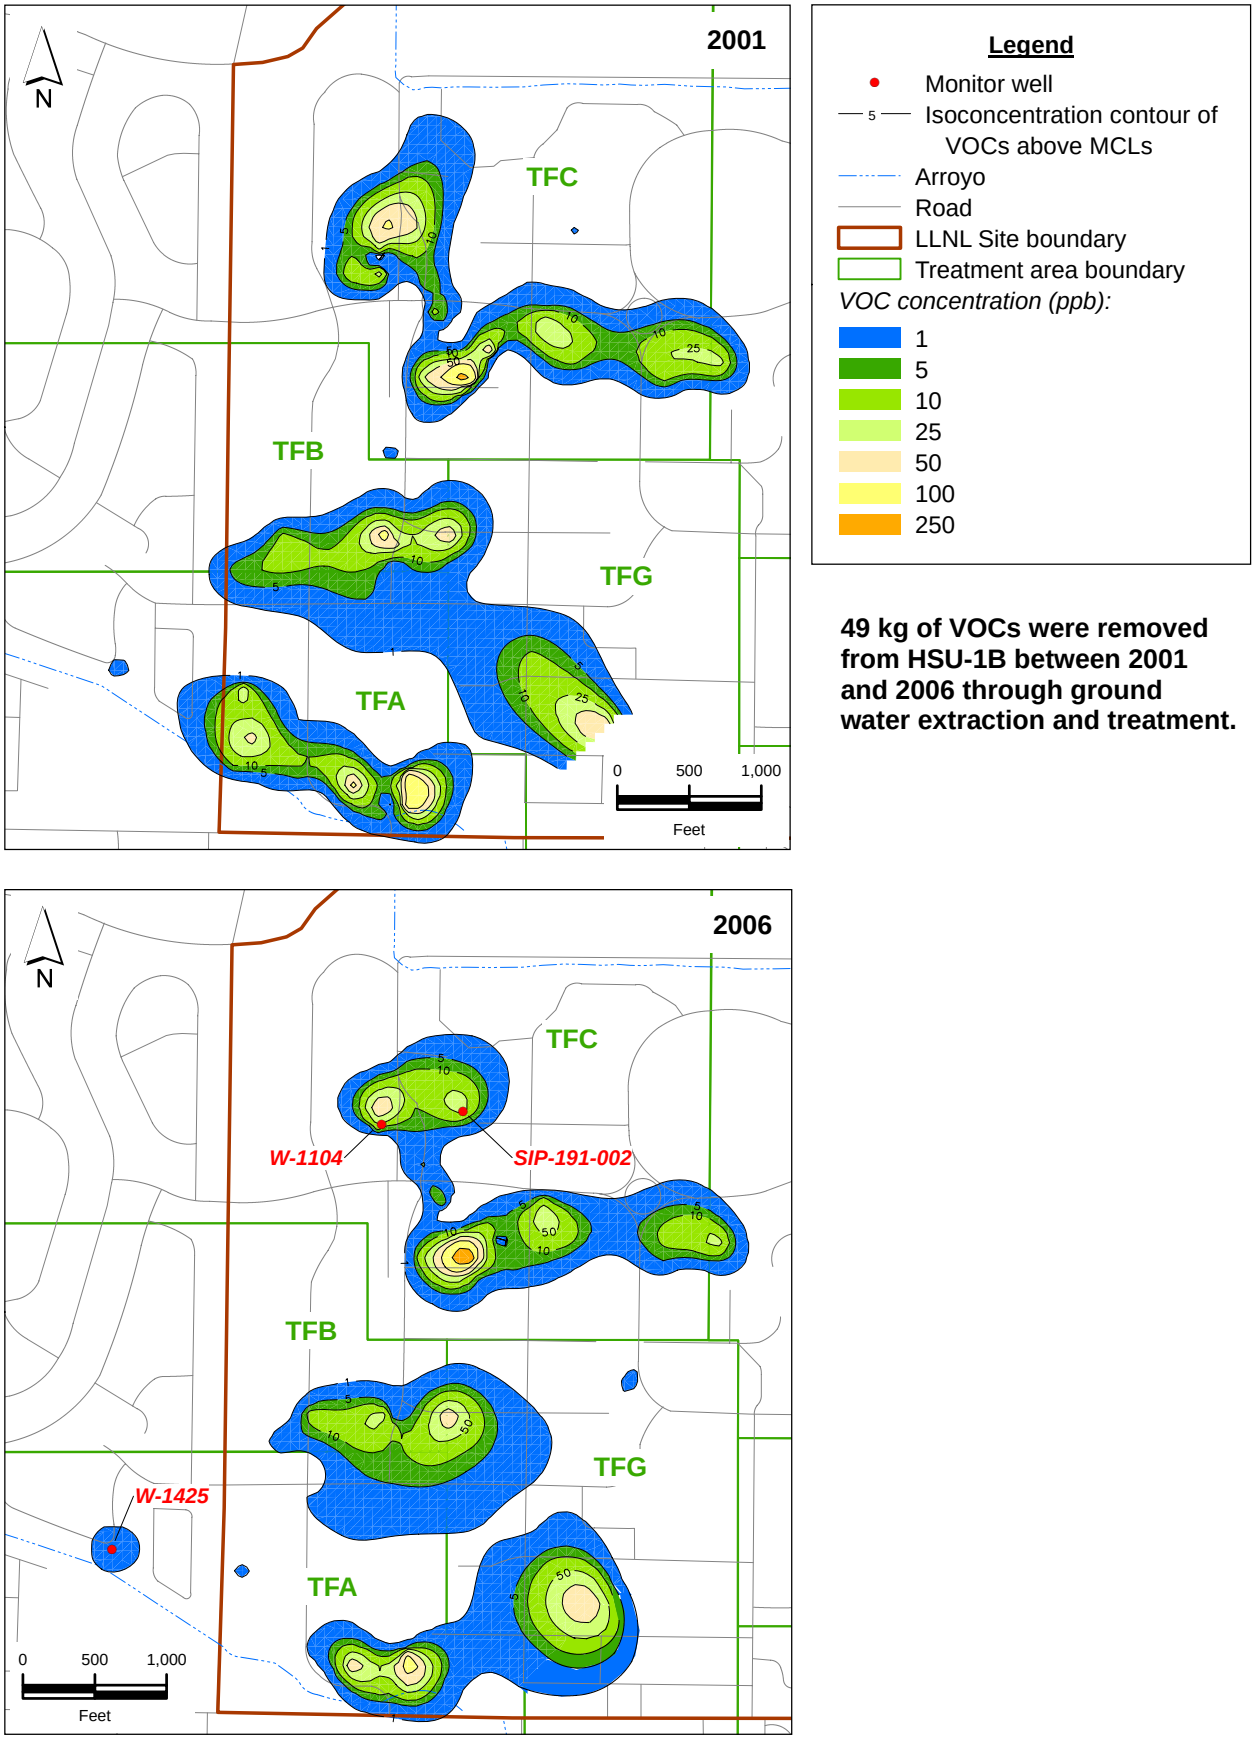
Figure 5. Time-series isoconcentration maps of VOCs above MCLs based on wells completed within Hydrostratigraphic Unit 1B (HSU-1B) for 2001 and 2006.

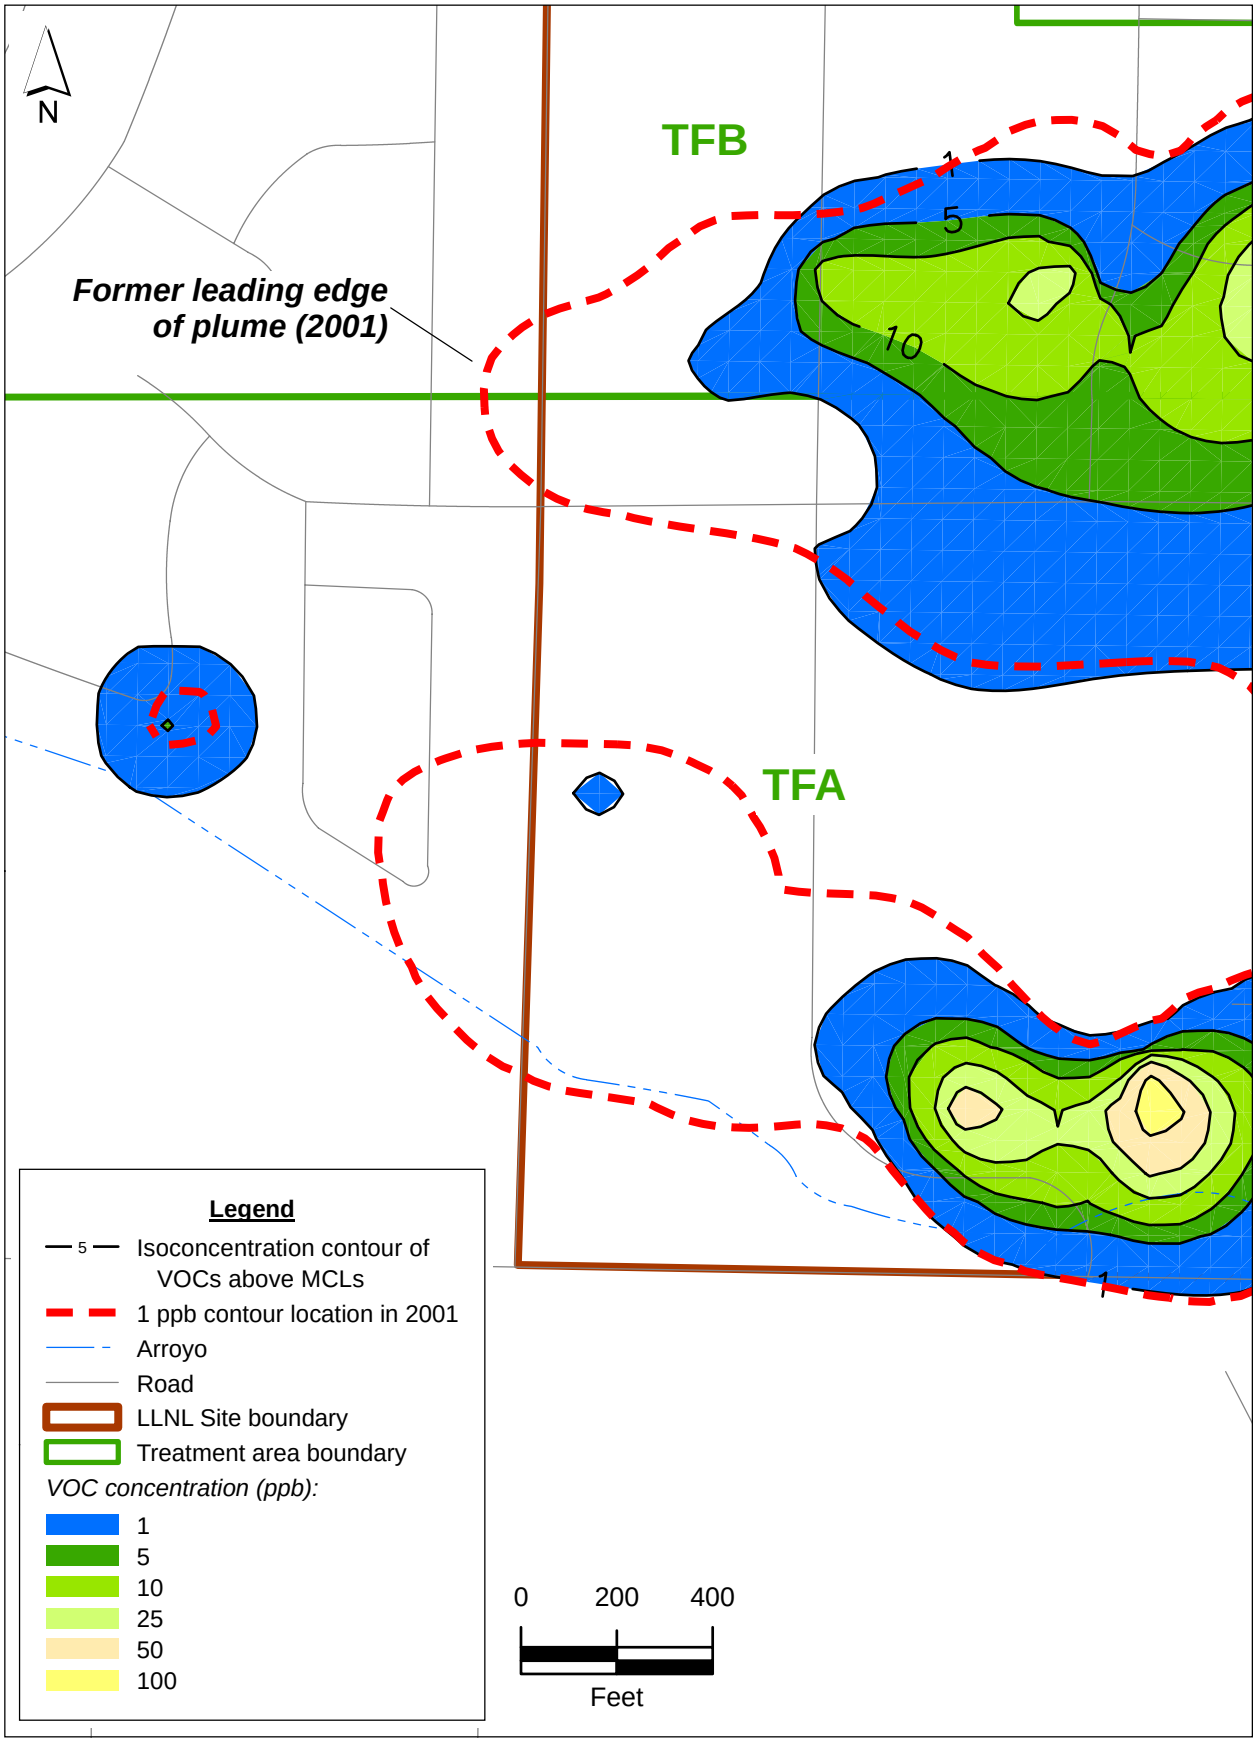
- VOC concentrations continued to decline in the TFA source area. PCE concentrations declined from maximum concentrations of 540 to 150 ppb.
- The TFB plume containing VOCs above the cleanup level retreated about 500 ft eastward toward the source area. No concentrations above MCLs remain offsite in the TFB area (Fig. 6).

- TCE concentrations have increased about 10-fold since 2001 at piezometer SIP-191-002 (from 5 to 47 ppb), suggesting the presence of a small, local source area (Fig. 6). Since this source area is within the hydraulic capture area of well W-1104, it poses no threat to offsite ground water quality. However, it will be further investigated under items listed in Section 8.

Figure 6. TFA and TFB area HSU-1B isoconcentration contour map of VOCs above MCLs showing the eastward retreat of the plume between 2001 and 2006.

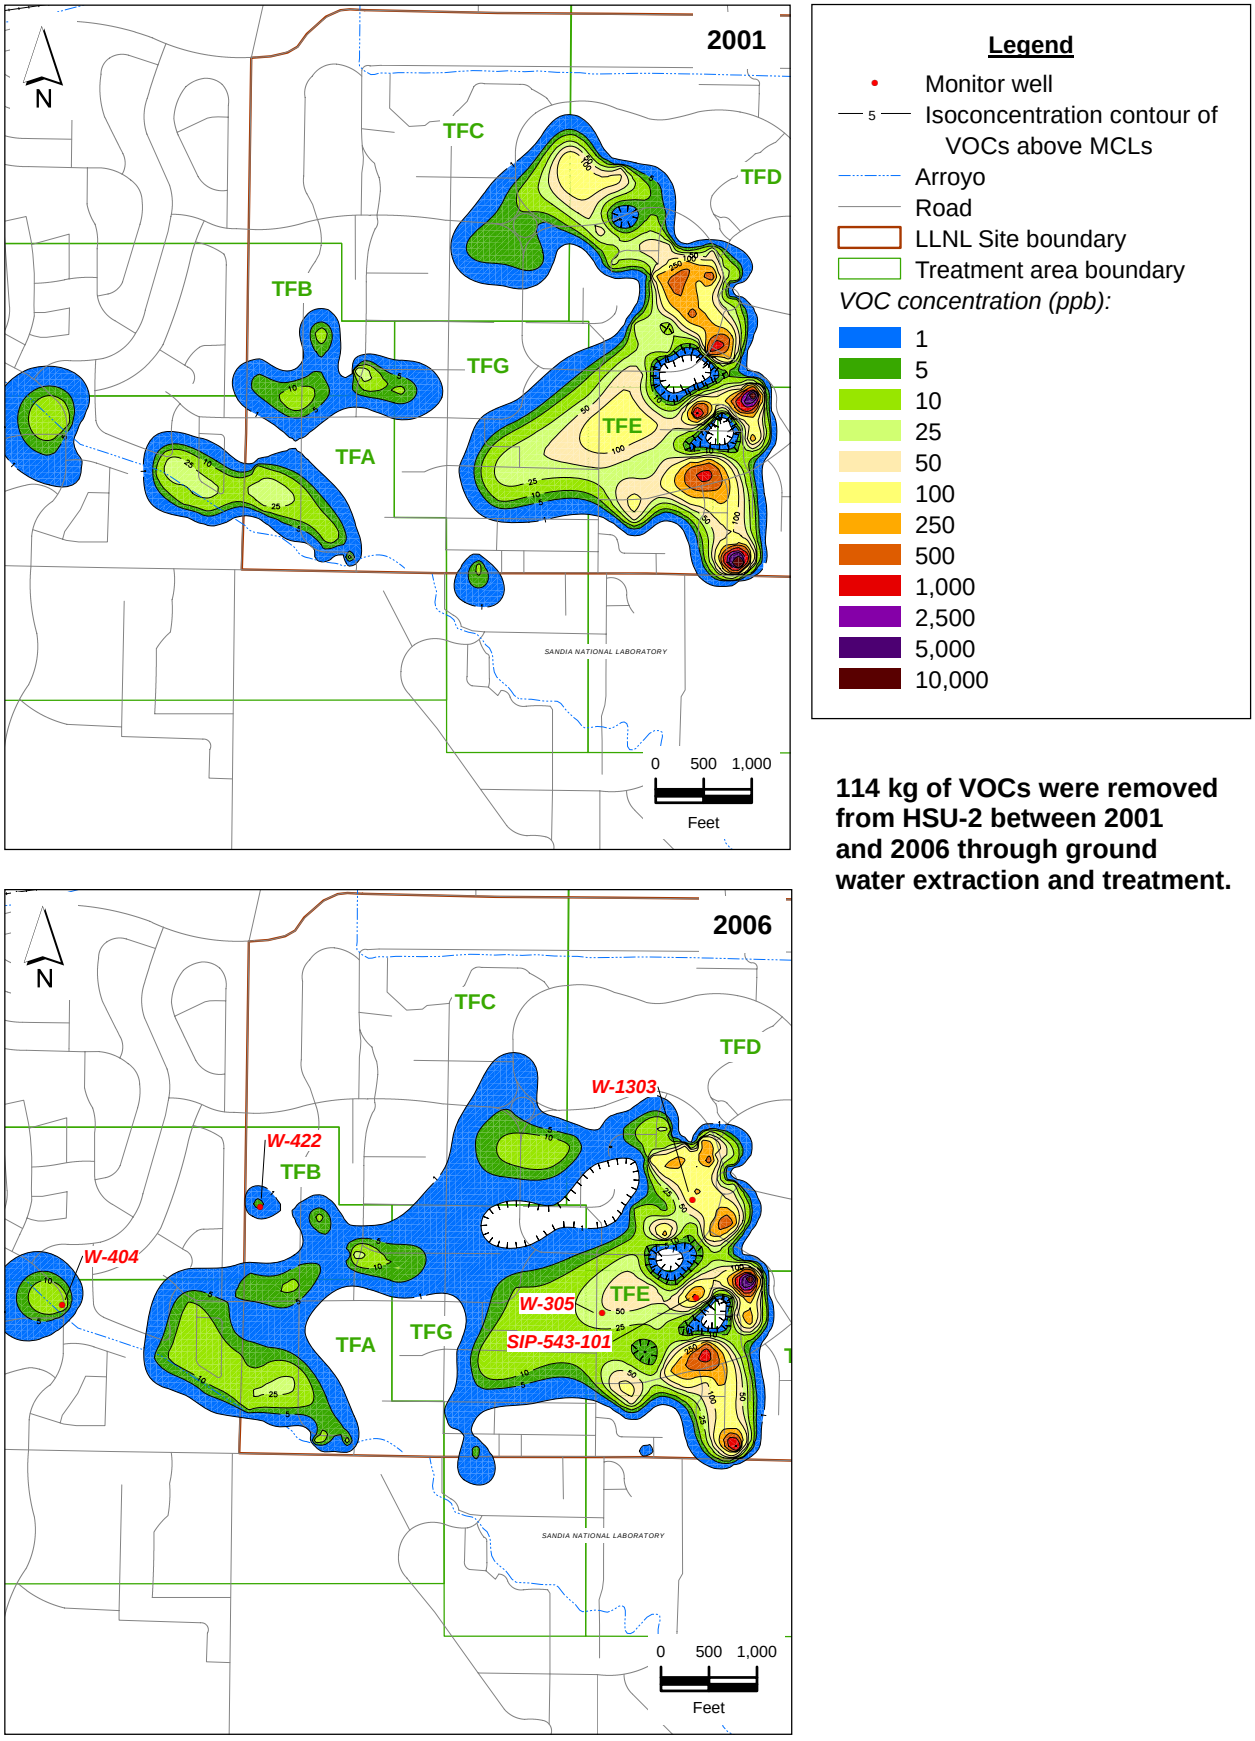
Figure 7. Time-series isoconcentration maps of VOCs above MCLs based on wells completed within Hydrostratigraphic Unit 2 (HSU-2) for 2001 and 2006.

114 kg of VOCs were removed from HSU-2 between 2001 and 2006 through ground water extraction and treatment.

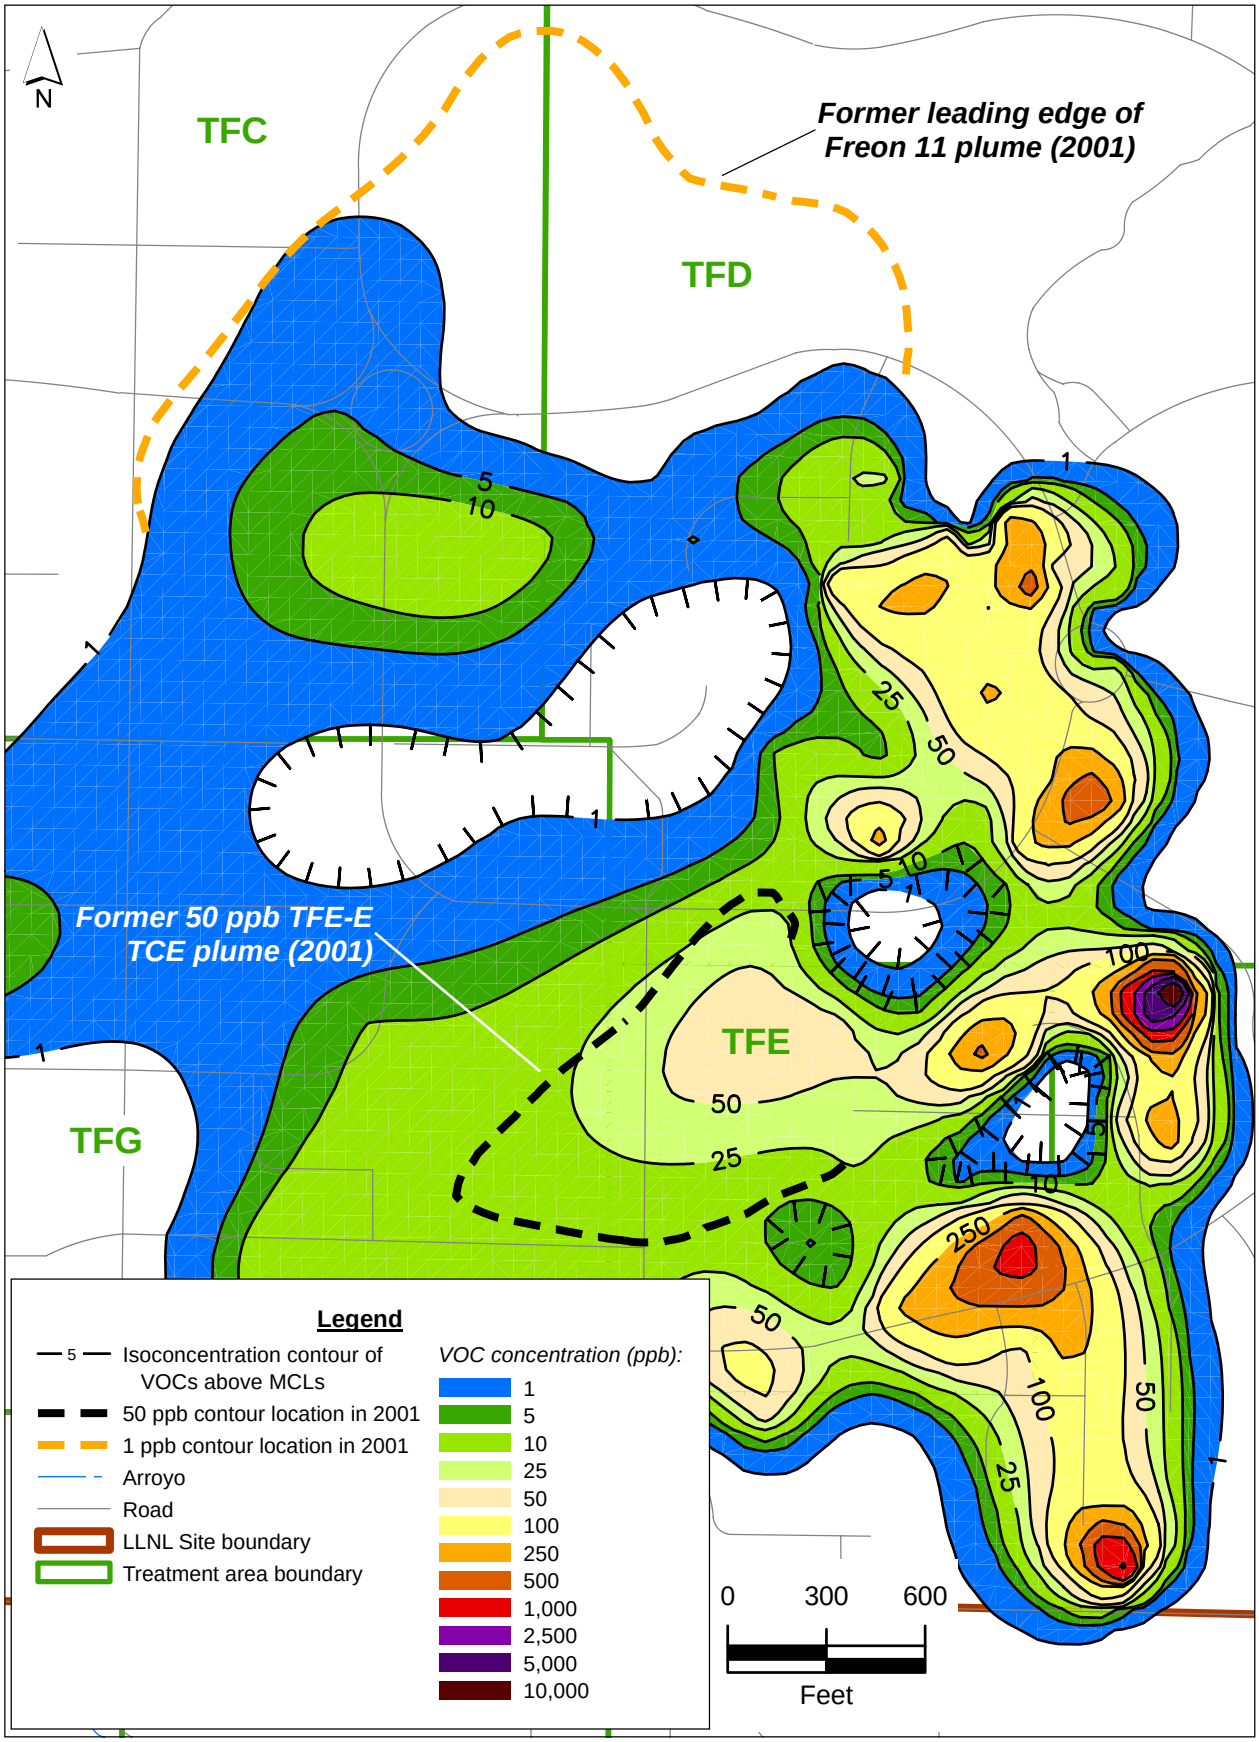
- The large, mobile Freon 11 contaminant plume north of TFD in HSU-2 has largely been reduced to below MCLs (Figs. 7 and 8). The remaining plume is being captured by treatment facilities TFD West and TFC East.

- Ground water TCE concentrations from the TFE East plume showed a significant decline due to pumping at TFE East, TFE West, and TFG North (Figs. 7 and 8). Total VOC concentrations at well W-305 declined from 220 to 44 ppb; both the 25 and 50 ppb MCL isoconcentration contours collapsed eastward about 750 ft. Concentrations in the source area decreased consistently over the same period in response to both ground water and soil vapor extraction (2,200 to 660 ppb TCE in SIP-543-101).

Figure 8. HSU-2 isoconcentration contour map of total VOCs above MCLs showing the retreat of the TFD area Freon 11 plume and the TFE area TCE plume between 2001 and 2006.

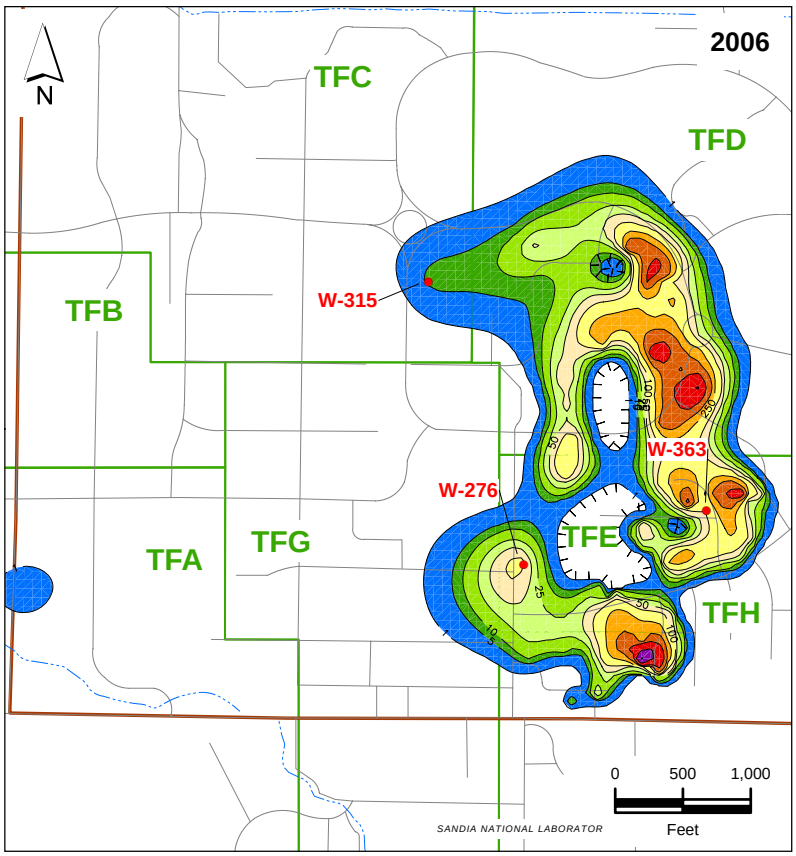
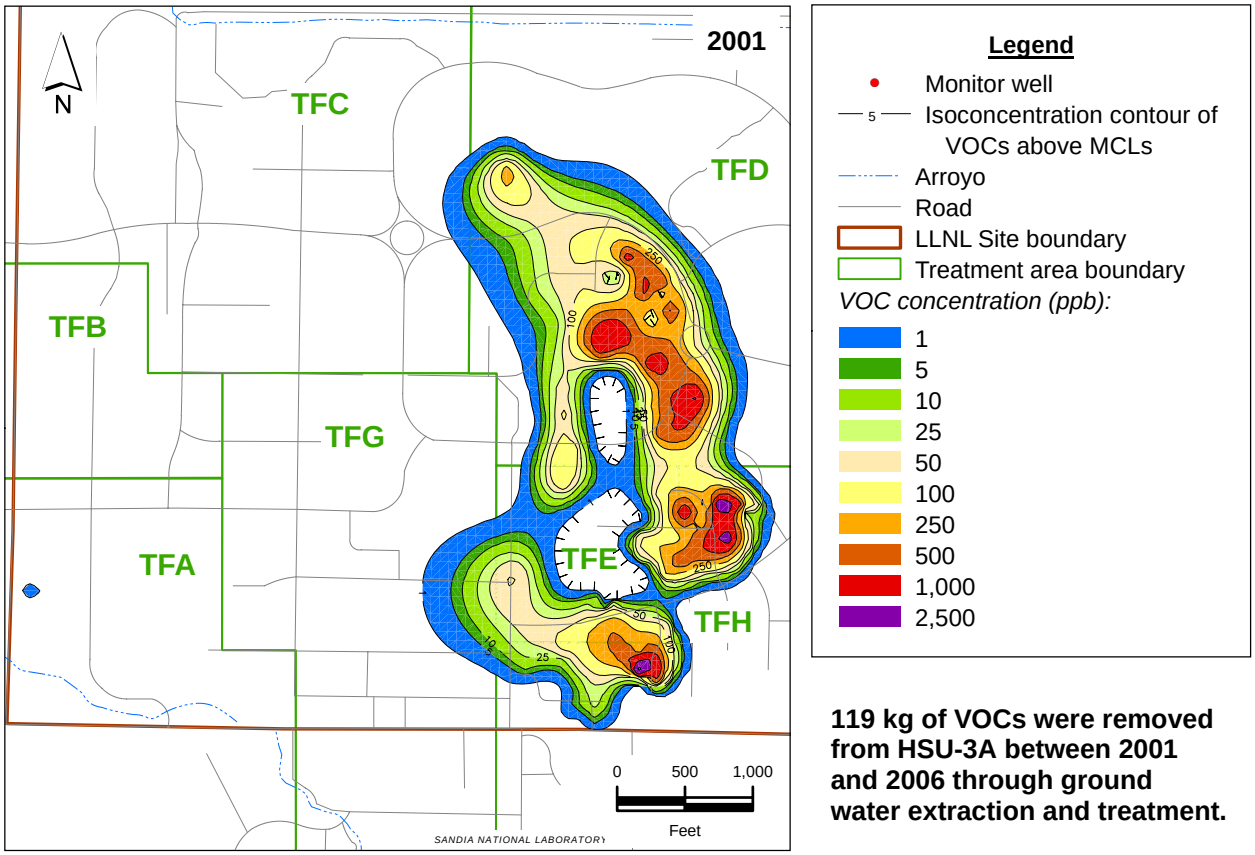
Figure 9. Time-series isoconcentration maps of VOCs above MCLs based on wells completed within Hydrostratigraphic Unit 3A (HSU-3A) for 2001 and 2006.

- In the TF5475 and eastern TFE areas, contaminant plumes consistently declined in concentrations. Total VOC concentrations at well W-363 declined from 710 to 255 ppb, and 808 to 423 ppb at well W-1201 (Fig. 9). However, concentrations remain well above MCLs in the Trailer 5425 area, where no active source area remediation is currently underway. In western TFE, a slight increase in concentration was noted in well W-276, where total VOC concentrations increased from 111 to 148 ppb. Similar increases were also observed in HSU-3B and 4. Both these issues will be further investigated under items listed in Section 8.

119 kg of VOCs were removed from HSU-3A between 2001 and 2006 through ground water extraction and treatment.

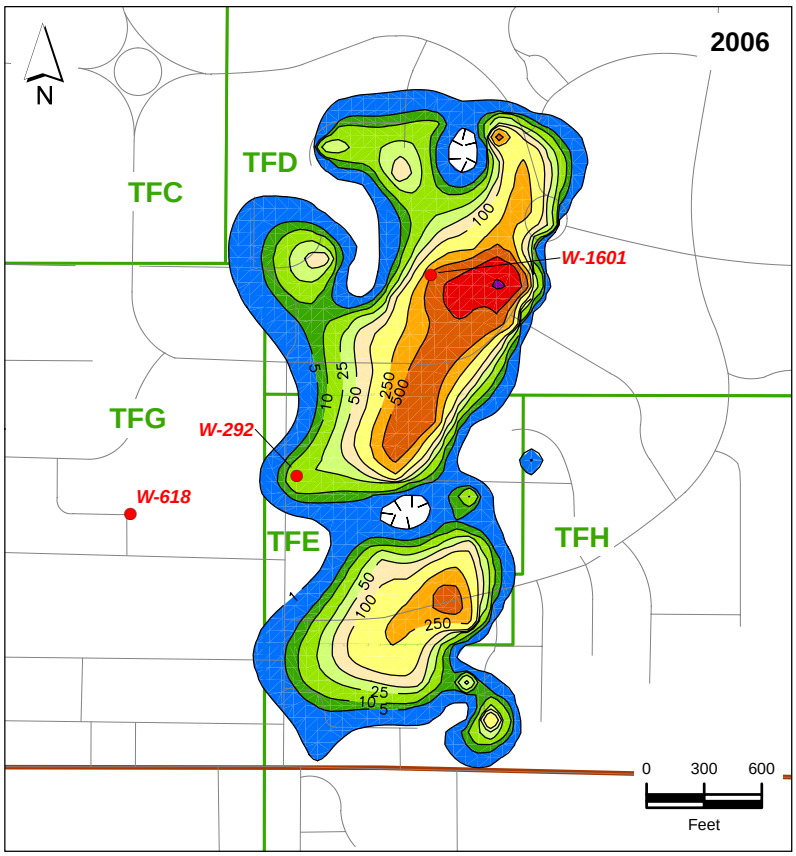
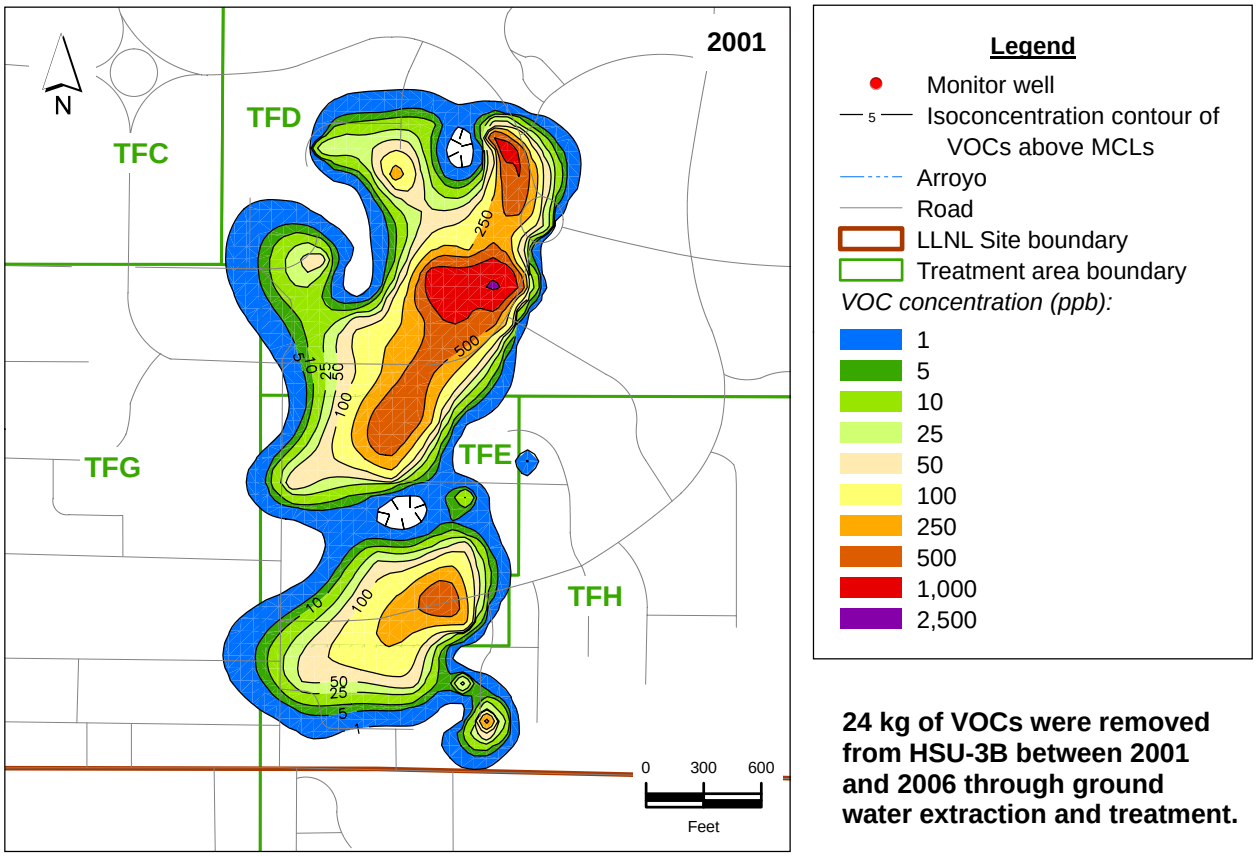
Figure 10. Time-series isoconcentration maps of VOCs above MCLs based on wells completed within Hydrostratigraphic Unit 3B (HSU-3B) for 2001 and 2006.

- VOC concentrations declined in the TFD Southshore area, where TCE reduced from 650 to 330 ppb in well W-1601 (Fig. 10).
- In 2004, VOC concentrations appeared in well W-618 for the first time, indicating the presence of a low concentration plume (below MCLs) located west of TFE West. Consistent decreases in concentration observed within the TFE West capture area (TCE concentrations

24 kg of VOCs were removed from HSU-3B between 2001 and 2006 through ground water extraction and treatment.

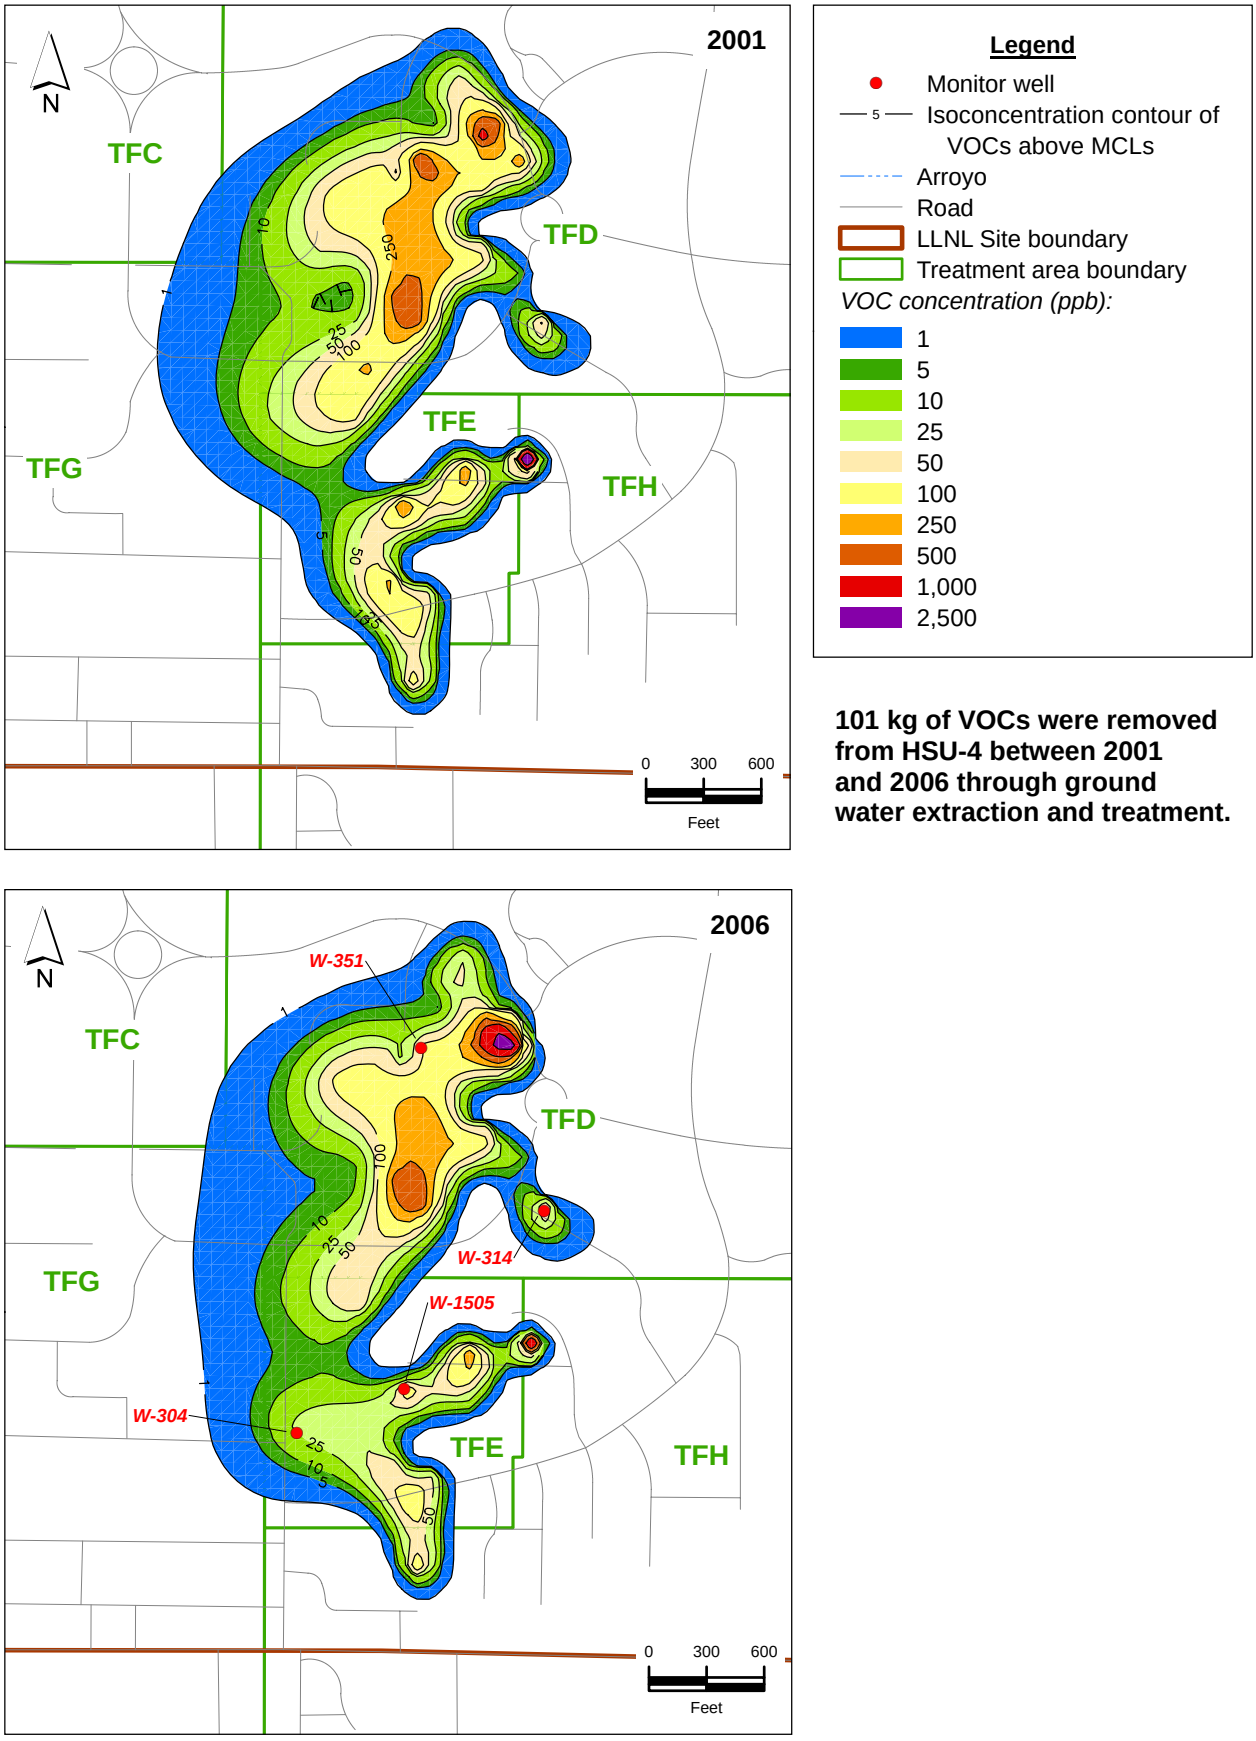
Figure 11. Time-series isoconcentration maps of VOCs above MCLs based on wells completed within Hydrostratigraphic Unit 4 (HSU-4) for 2001 and 2006.

101 kg of VOCs were removed from HSU-4 between 2001 and 2006 through ground water extraction and treatment.

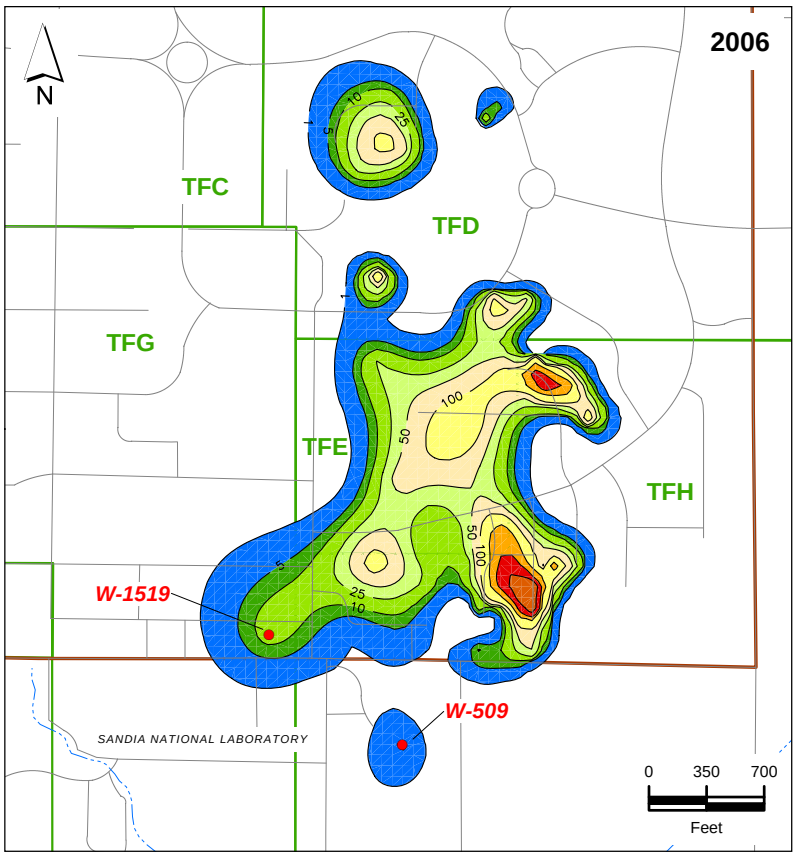
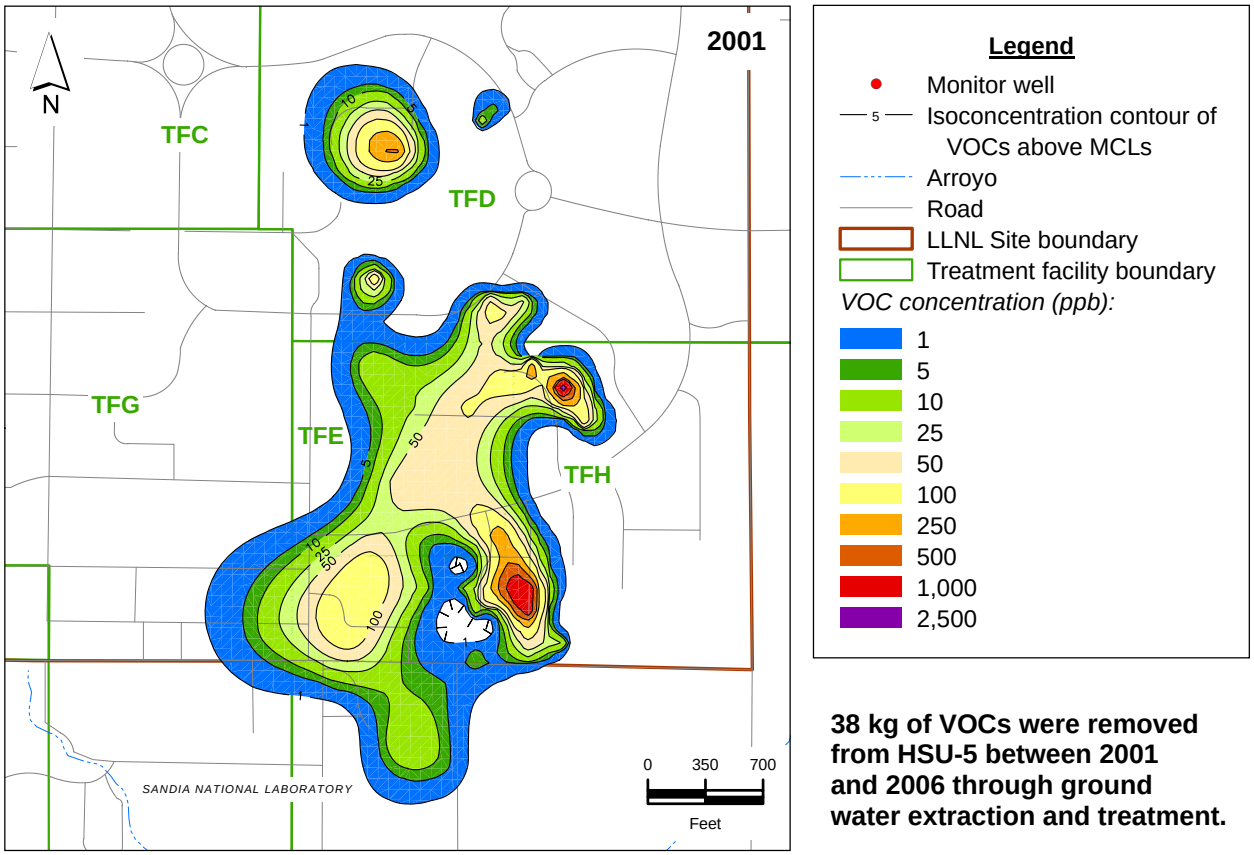
Figure 12. Time-series isoconcentration maps of VOCs above MCLs based on wells completed within Hydrostratigraphic Unit 5 (HSU-5) for 2001 and 2006.

38 kg of VOCs were removed from HSU-5 between 2001 and 2006 through ground water extraction and treatment.

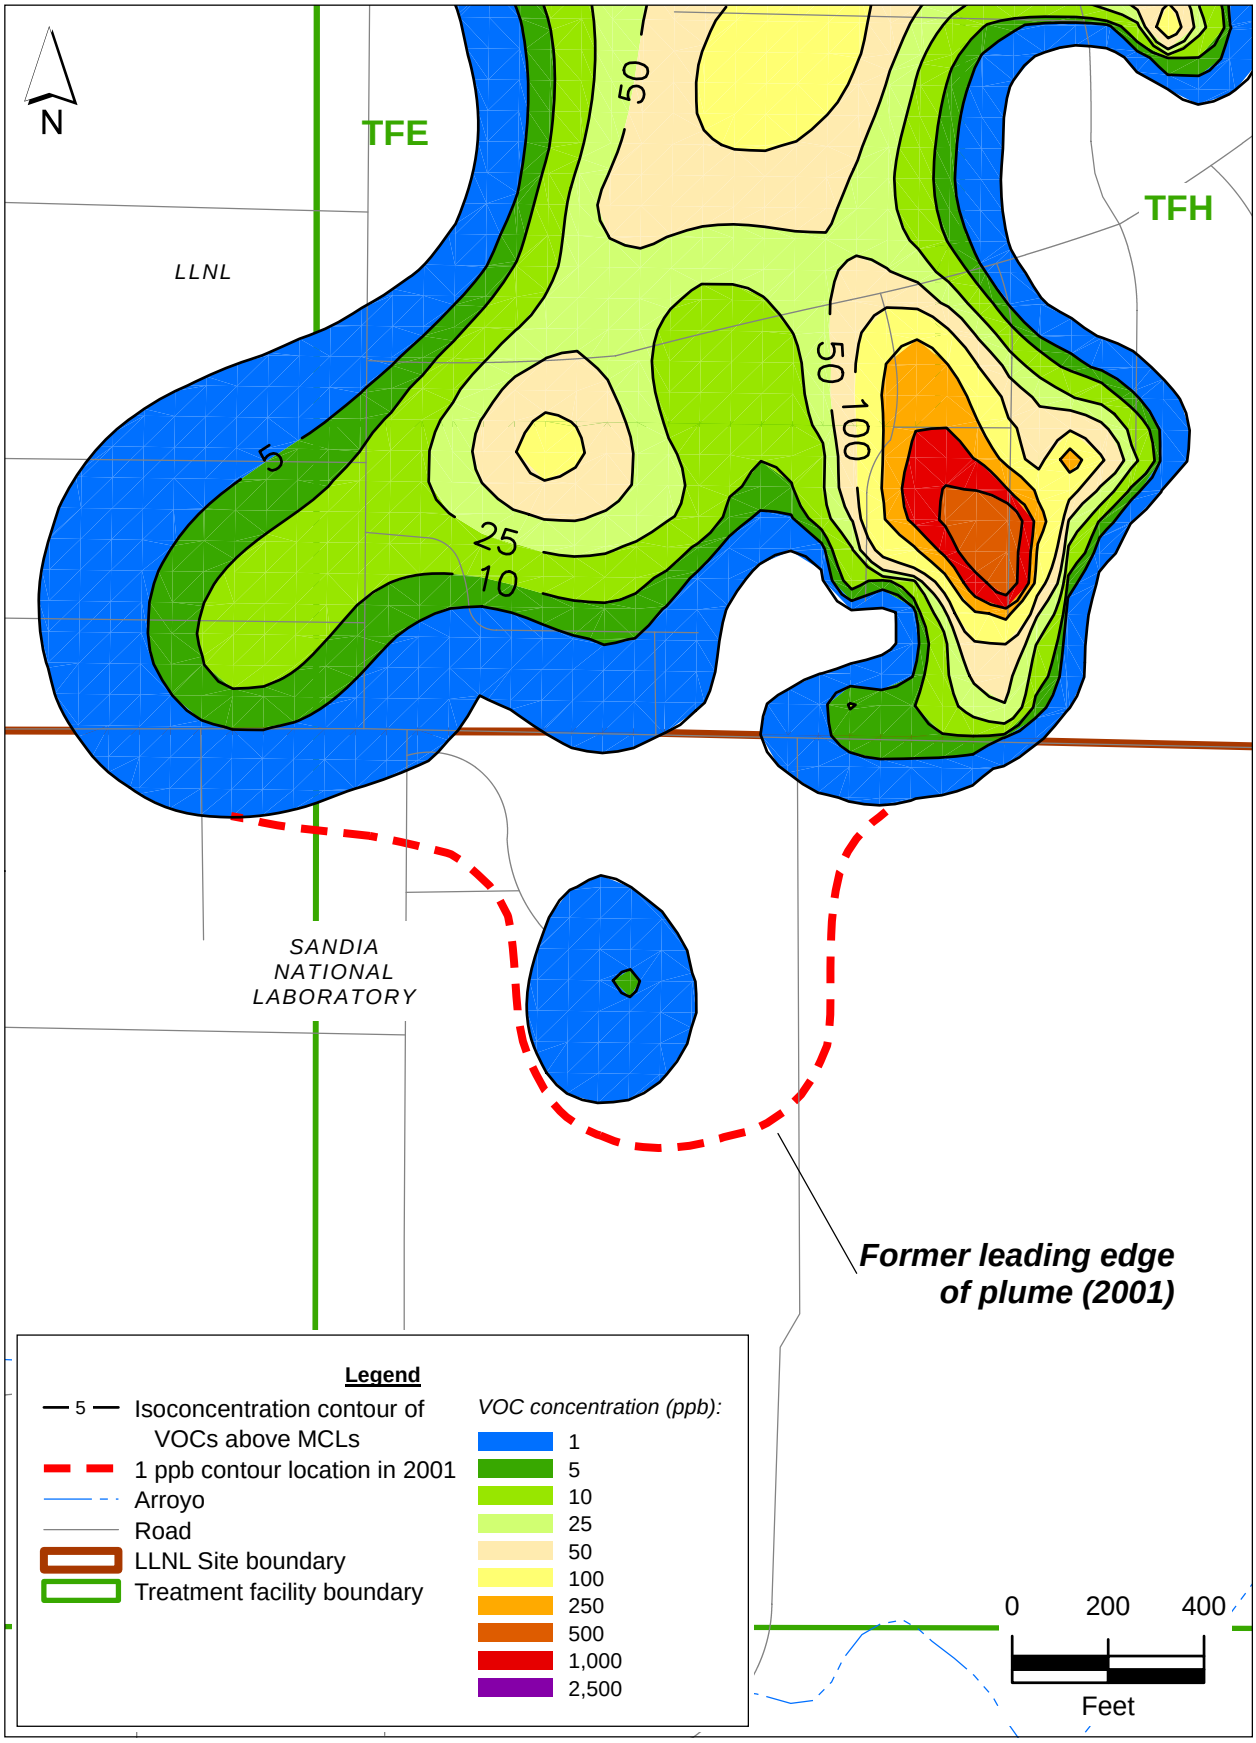
Figure 13. TFH area HSU-5 isoconcentration map of total VOCs above MCLs showing the northward retreat of the plume between 2001 and 2006.
